**Equalize Air Inspection Report
Canadian Tire
Peterborough Store**

Prepared for: Enbridge Gas Distribution

Date: February 9, 2005

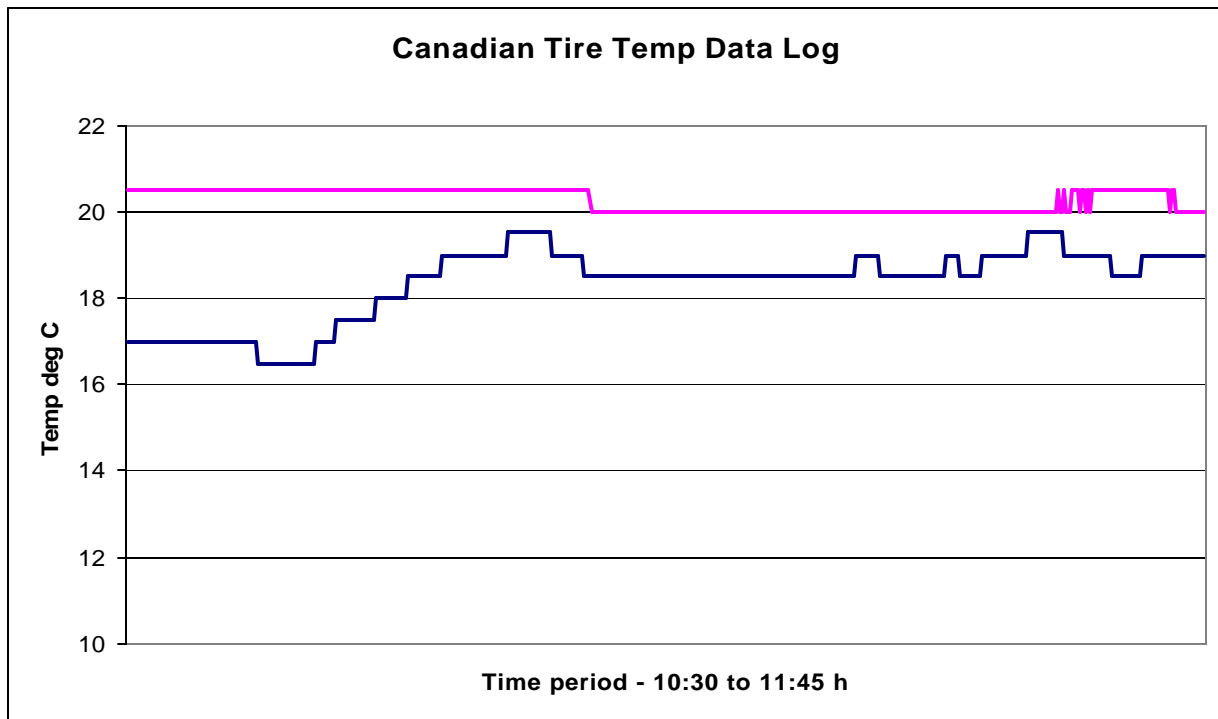
Figure 7

The data from the loggers clearly shows in “Figure 7” how the floor temperature rises once the units are turned on. Individual charts of the data loggers can be found in Appendix 1 and 2 to more clearly show the data from the loggers.
